SUSQUEHANNA RIVER BASIN
NEGLEY DAM
WILBUR R. NEGLEY, JR.

NDI NO. PA-00948
DER NO. 50-061

PHASE I INSPECTION REPORT.
NATIONAL DAM INSPECTION PROGRAM.

Name of Dam: NEGLEY DAM
State & State No.: PENNSYLVANIA, 50-61
County: PERRY
Stream: TRIBUTARY TO LITTLE JUNIATA CREEK
Date of Inspection: NOVEMBER 4, 1980

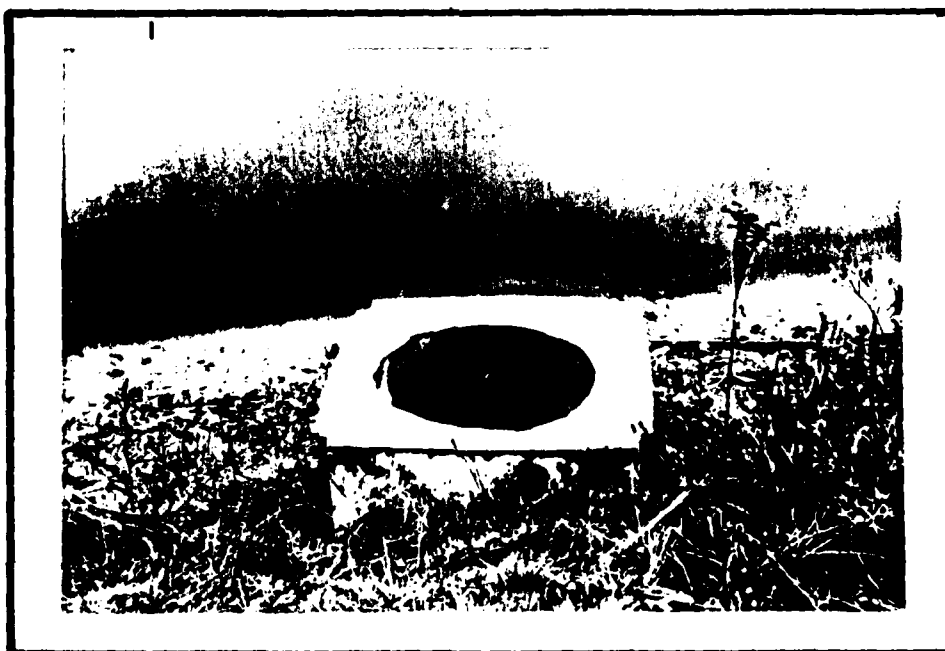
Post construction changes reported by the owner consisted of the replacement of the principal spillway intake. The concrete of the original structure deteriorated badly and was replaced in the fall of 1980 by the present concrete encased CMP.

The principal spillway consists of a 34-inch CMP drop inlet pipe, encased in concrete (Photograph No. 5). Discharge is through an 18-inch CMP which terminates at the downstream toe. A small rock lined plunge pool prevents erosion. The area is overgrown with weeds and briars (Photograph No. 6). The outlet was constructed without a headwall.

The only reported post construction change is the replacement of the principal spillway overflow section. The original concrete section was of poor quality and deteriorated due to freeze-thaw cycles. The upper part was replaced with an encased corrugated metal pipe.

PRINCIPAL SPILLWAY - NO. 5
